## Historic Structure Report for St. Anne's Church

# Historic Structure Report for St. Anne's Church

National Park Service  
Historic Preservation Fund Project  
#23-11-NA-2314  
July 2013

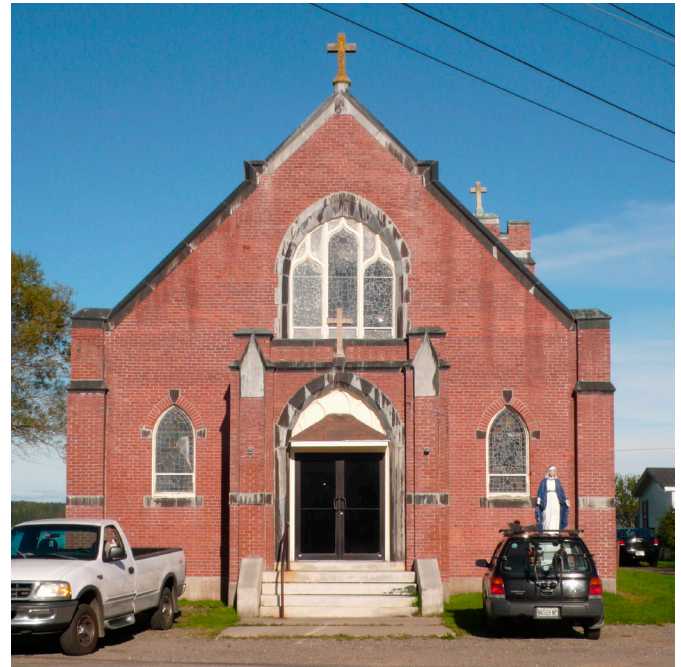
» There are engaged brick pilasters on each side of the entry, as are arch topped stained glass windows. The brick and mortar are in fair condition.

*West elevation of the church.*

» Stained glass, here as in all other cases should be restored (glass, metal frames and wooden sash) as necessary. Existing (Unvented) Plexiglas sheets should be removed and replaced with a (glass or Plexiglas) system that provides passive ventilation to the exterior of the stained glass window. This will minimize future deformation and failure of the irreplaceable stained glass  
 » Stained glass window at Choir Loft should be inspected and repaired as necessary (glass and frame.)

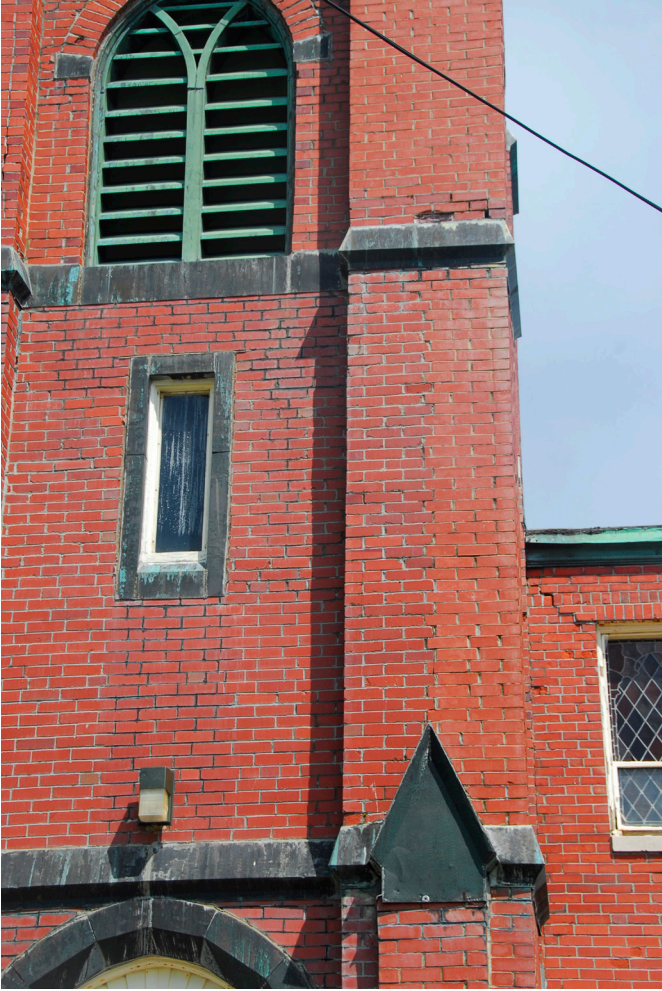
*Example of poorly executed brick repair & replacement. Note the different colors of brick and mortar.*

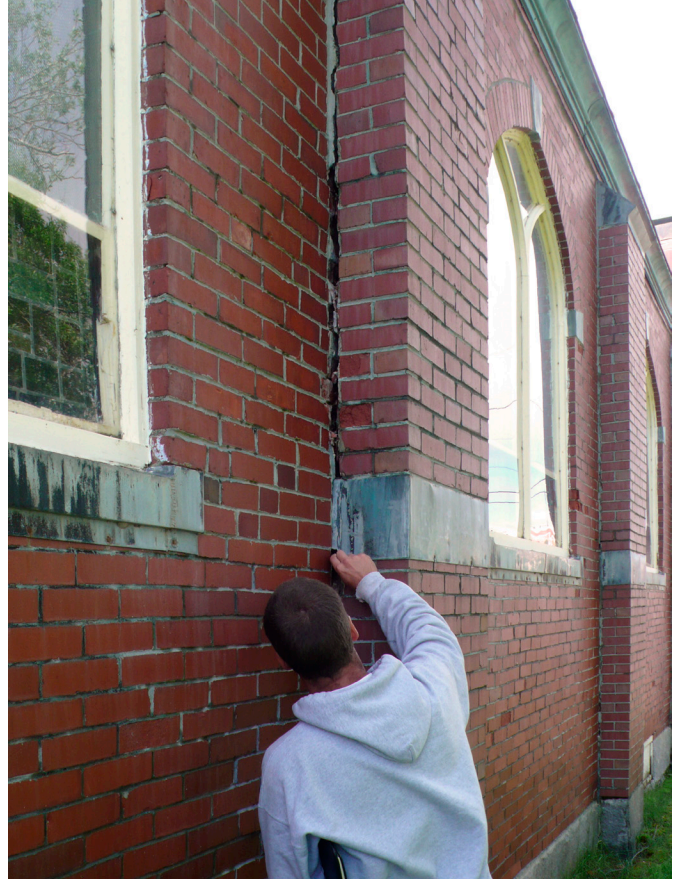
- » Brick pilaster failure is prevalent. The gaps between primary brick face and the pilaster masonry must be addressed. Inspection of several pilaster connection points and corners suggest major moisture infiltration and deterioration of mortar. Freeze/thaw cycle has caused the masonry to become unstable. However, separation from primary masonry plane has remained remarkable vertical and consistent. Structural analysis may recommend removal of the pilasters at all locations. Structural steel may need to be added to carry the buttressing loads to foundation. Rebuilding of pilasters will then be required. Care must be taken to match adjacent brick as closely as possible relative to size, dimension, color and texture. As noted, existing brick in several locations suggests Canadian foundry origin.

*Example of brick pilaster failure. The pilasters are the attached exterior columns of the main church which match the roof truss framing. They appear to be non-structural and intended as decorative elements. Most of them are separating from the building. This is the worst example on the North side. As wind driven water gets into the crack it increases the deterioration of the mortar bond.*

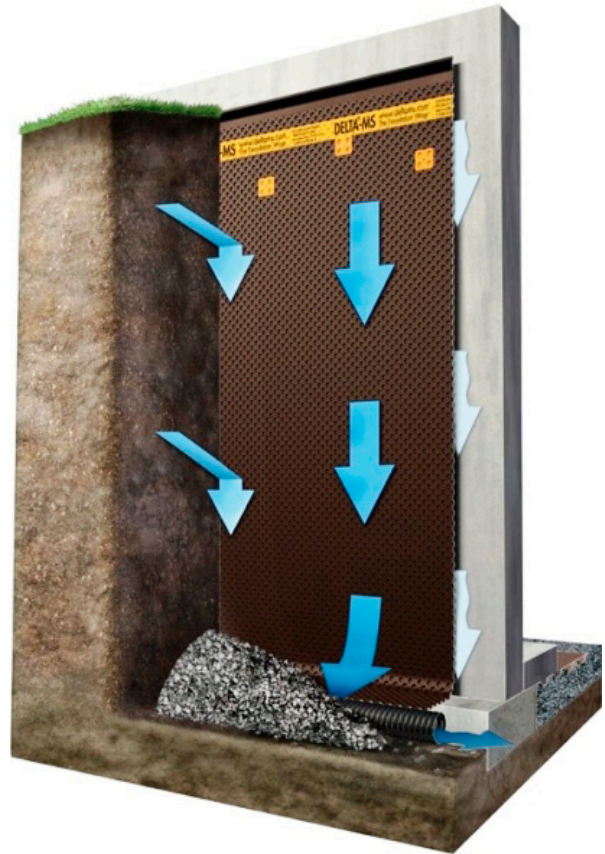
*Example of the type of perimeter foundation drainage system which is recommended*

» Perimeter drainage excavation should be performed at entire building perimeter adjacent to foundation. Severe moisture infiltration into basement will be eliminated. This perimeter drainage system is a critical aspect of restoring this property. Note: The entire facility lacks conventional gutters and leaders. This causes all runoff to sheet off the roof (Church) or pond at the Convent. It would be architecturally prohibitive to add gutters and leaders to this aesthetic. Therefore, runoff would continue as it does at the Church perimeter, falling into the new perimeter drainage system designed for this situation. At the Convent, the concrete slab roof should be modified for positive drainage to (existing) roof drain and two additional drains strategically placed for positive drainage collection. Tapered insulation is part of the revised roof solution. The new rubber (EPDM) membrane would be fully adhered and incorporate these elements. Considering the excessive wind exposure on the

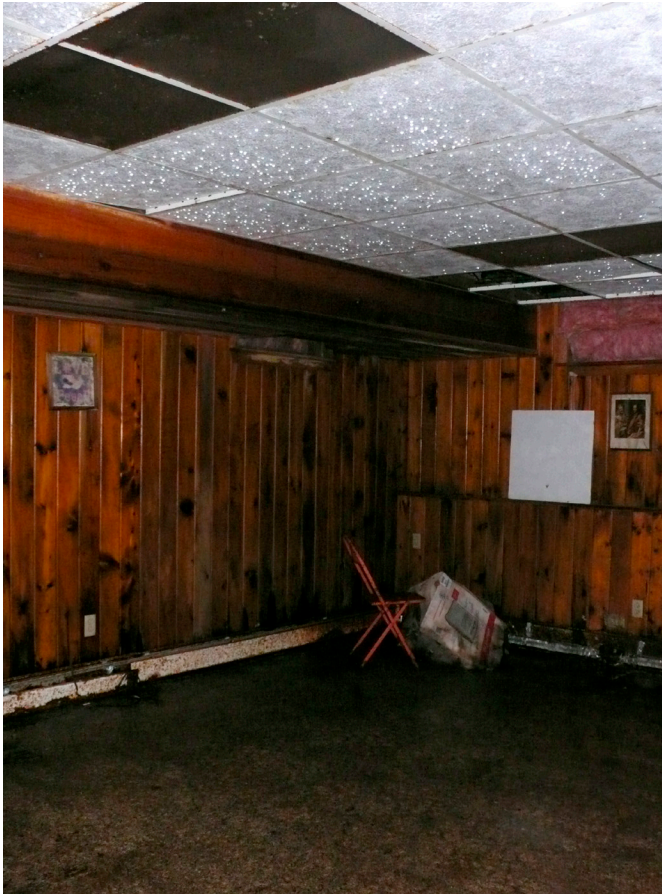
*Basement of the Convent. Water infiltration through the foundation, and from the roof along with the lack of ventilation (from blocking up the windows) has created an environment of extremely high humidity. All steel is rusting. All wood is rotting. Mold and mildew are rampant.*

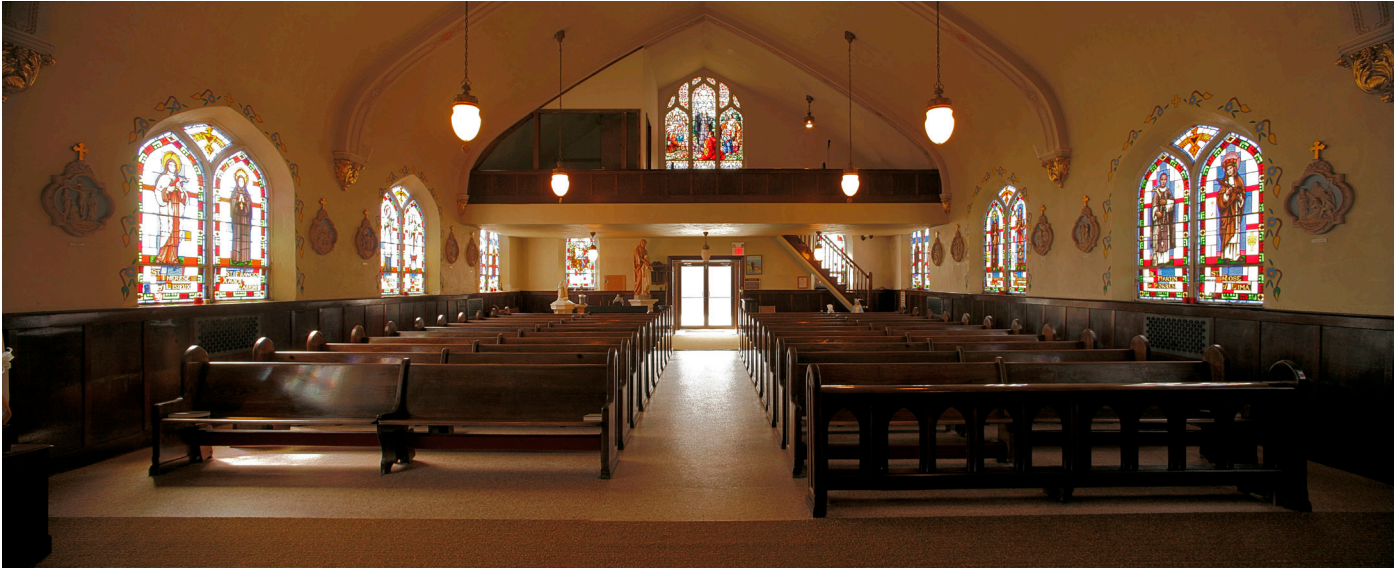
*Interior of the chapel, looking towards the west from the alter. The chapel remains in surprisingly good condition as it has remained heated throughout its life. Plaster suffers greatly in the Northeast when the interior spaces are not heated in the winter. The plaster collects moisture from condensation and rapidly disintegrates through the action of the freeze/thaw cycle. This is why we see a profound difference between the condition of the chapel and the convent, the latter of which has been unused and unheated for over ten years.*

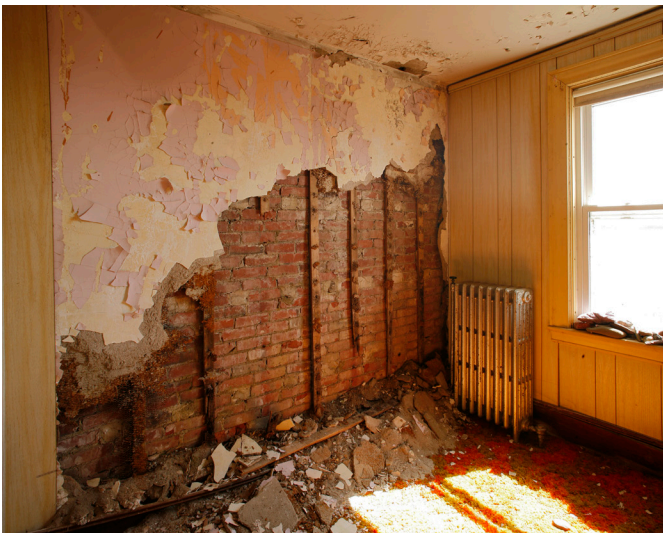
*Typical conditions on the second floor of the convent. Wind driven rain combined with water leaking from the roof, saturates the brick, causing runoff on the inner side of the brick wall, deteriorating the plaster and lathe and soaking the hardwood floor under the carpet.*

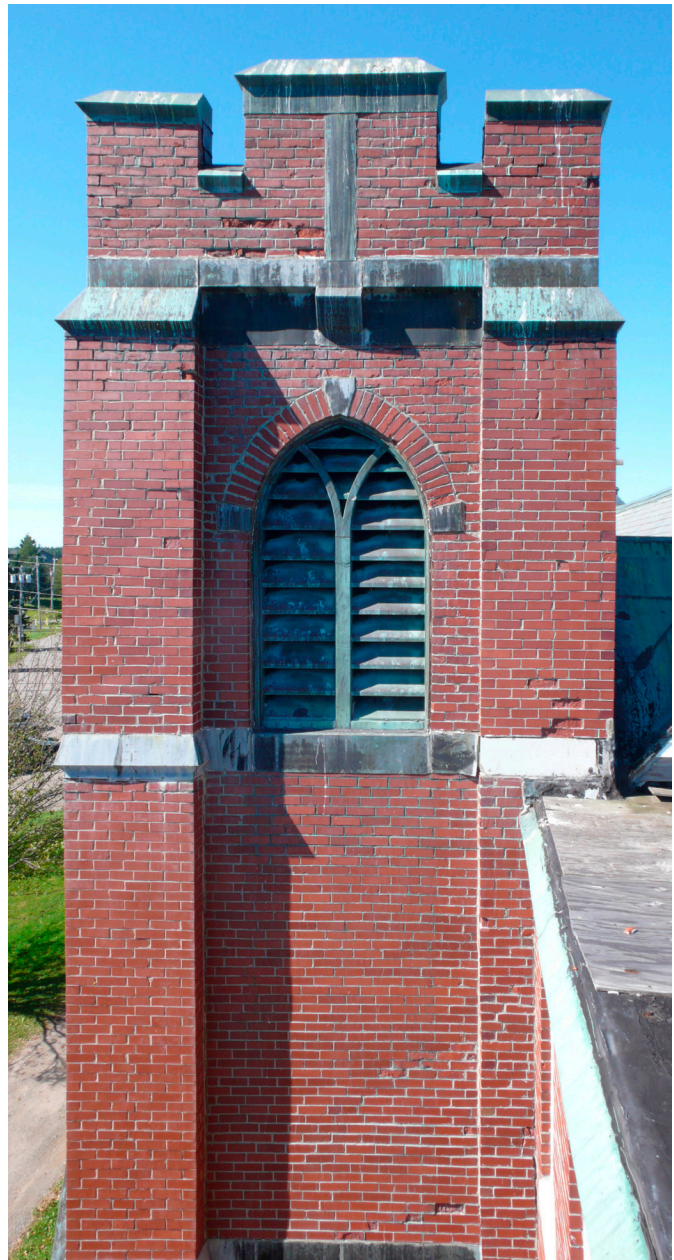
*Bell Tower (East Elevation.) Numerous brick repairs of varying quality along with instances of improper re-pointing have led to the condition of serious deterioration on the tower.*

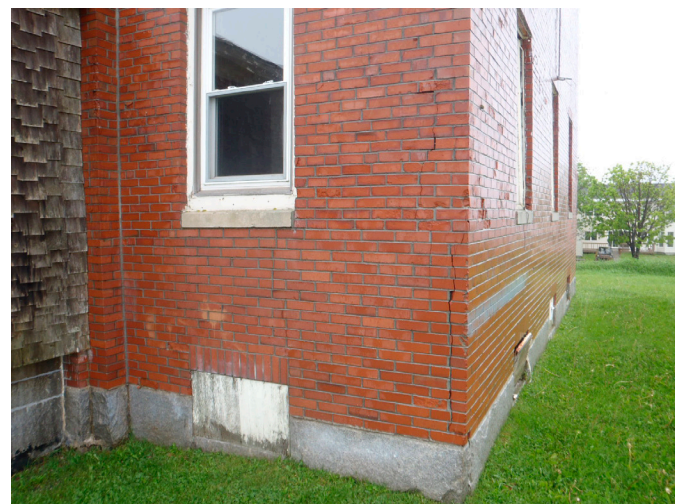
*Photo 24: Cracked and spalling bricks at the southeast corner of the dormitory.*

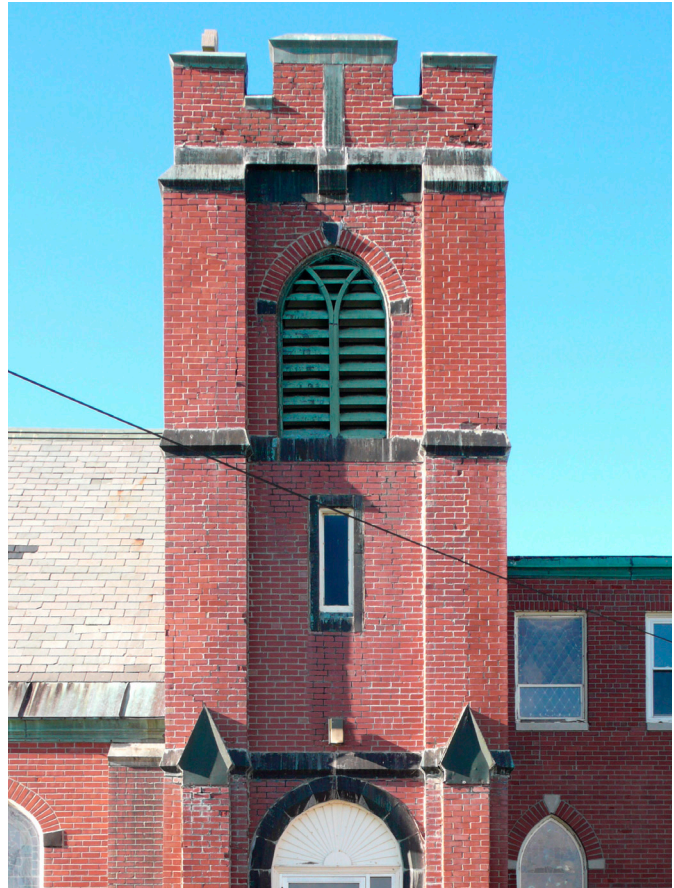
*Areas of non-original brick from previous repairs can be seen throughout the building exterior. Differences in color, texture, manufacturer and size of the brick are easily seen in this photo.*

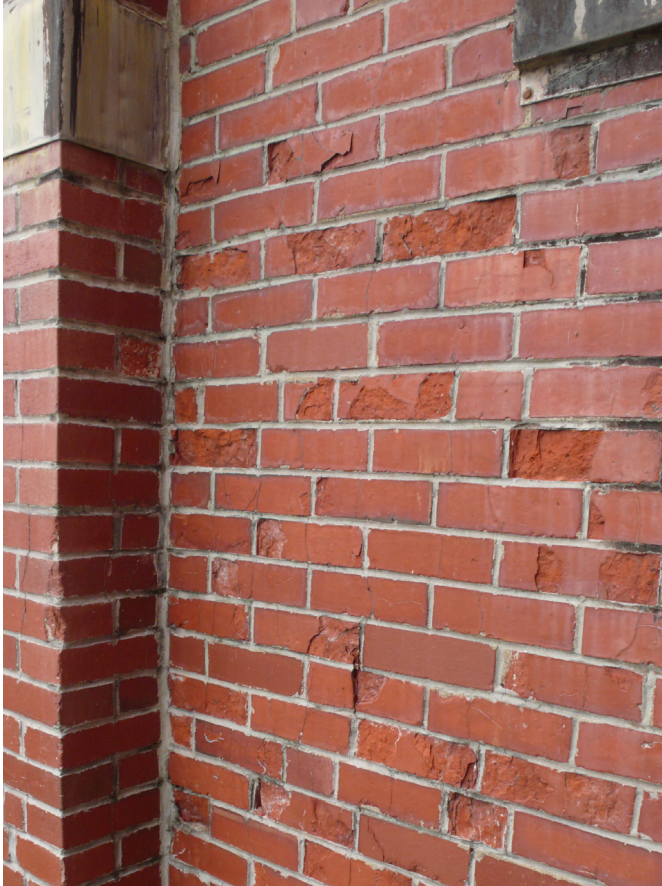
*An example of the extensive brick face spalling.*

Spalling is caused primarily by the bricks becoming over saturated with water while going through repeated freeze/thaw cycles. Over time, the action of freezing, which expands the water, along with temperature differential between the interior and exterior, slowly fractures the aggregate bonds on a microscopic level. Shear lines form along weaknesses in the brick reducing it to flaking shards, which peel off at the surface. At this point the structural integrity of the brick is lost and the only remediation is to replace the brick entirely..

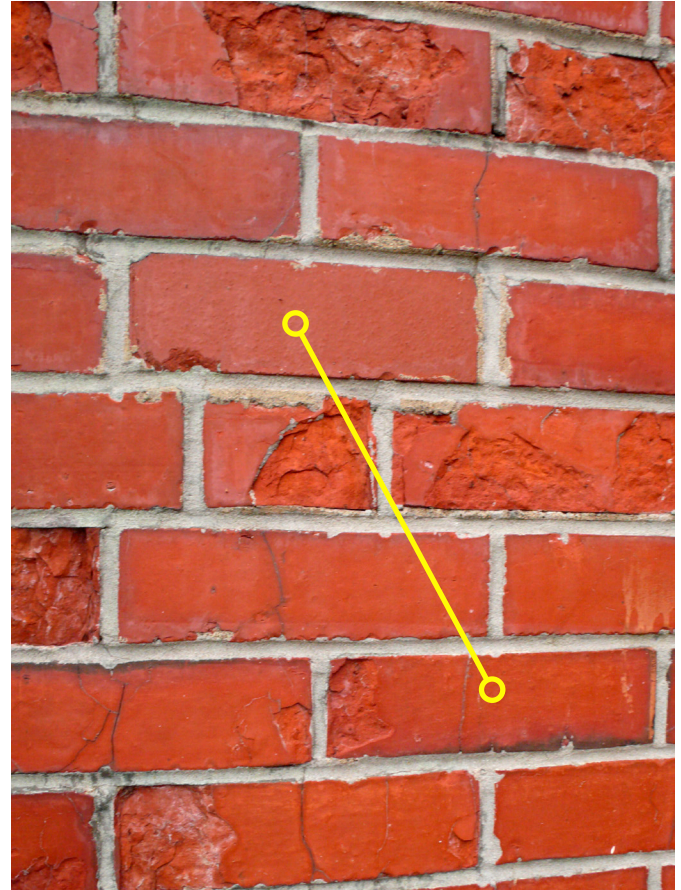
*Close up of the spalling. Note the different colored / sized bricks on the top and bottom and the sloppy re-pointing with various mortars.*

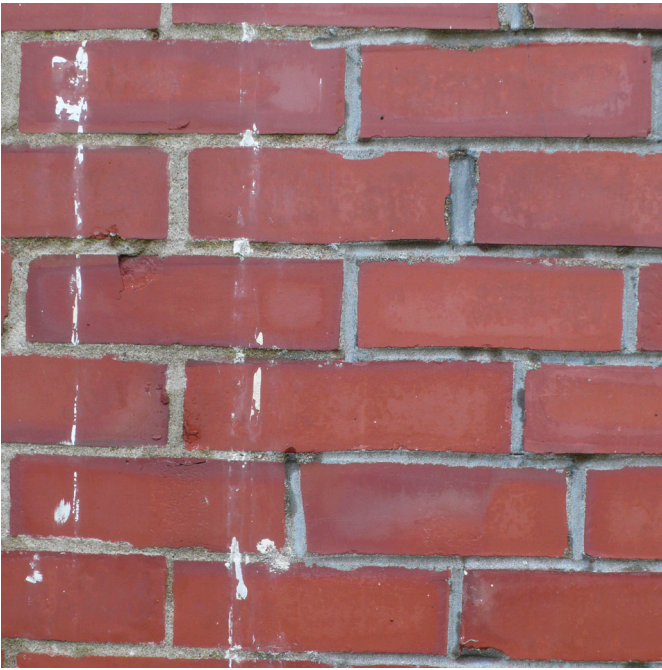
*Historic mortar on the left with newer mortar on the right. The older mortar has a larger aggregate is more porous and is softer. The newer mortar is smoother, harder and less porous. The latter is bad for the brick because it transfers all of the stresses to the brick (which is hard to replace) rather than the mortar (which is easier to replace.)*

- The new mortar must match the historic mortar in color, texture and tooling. (If a laboratory analysis is undertaken, it may be possible to match the binder components and their proportions with the historic mortar, if those materials are available.)
- The sand must match the sand in the historic mortar.

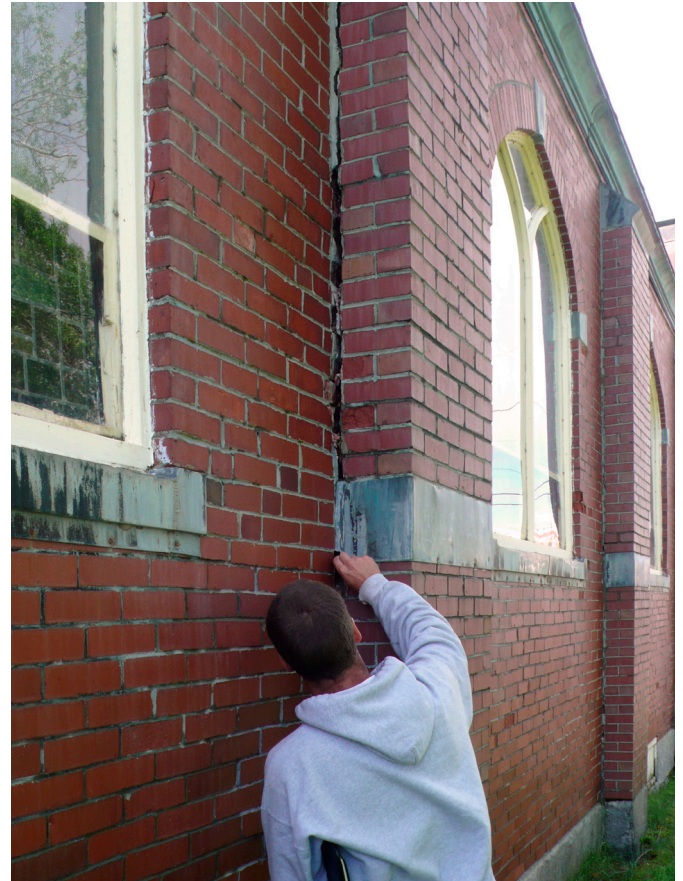
*Mason Ben Cawley inspecting a pilaster on the North facade. Note the 1" gap between the pilaster and wall. Mortar has deteriorated and water is penetrating deep into the wall cavity.*

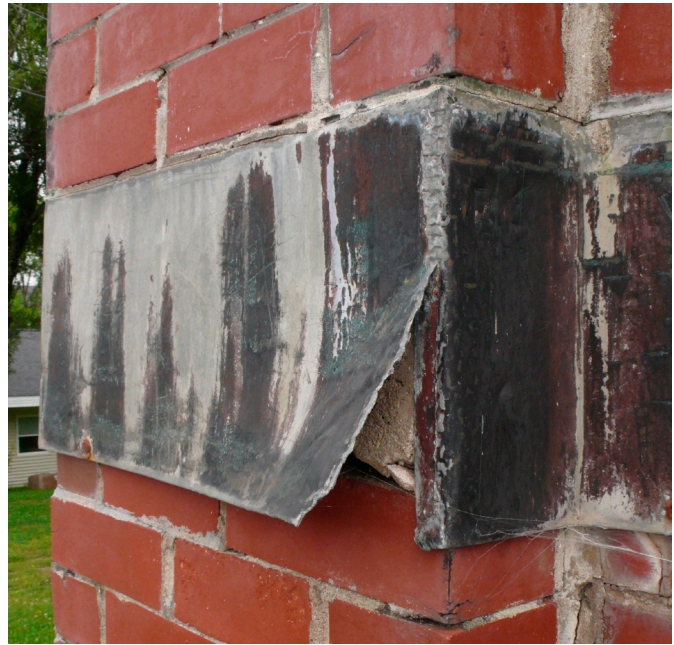
*Lead coated copper flashing covering a precast concrete block. Here the flashing has been damaged, revealing the concrete underneath.*

» Restore/replace existing copper/lead coated flashing as elsewhere . Proper mastic and mechanical fastening as required to create impermeable seal and architectural integrity.

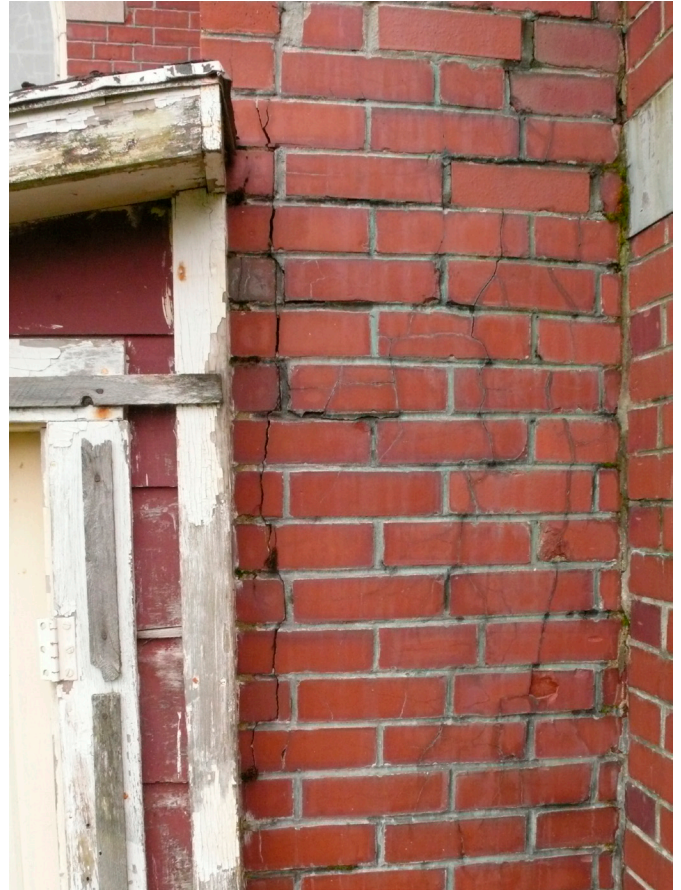
*Advanced brick deterioration on the North side of the Chapel.*

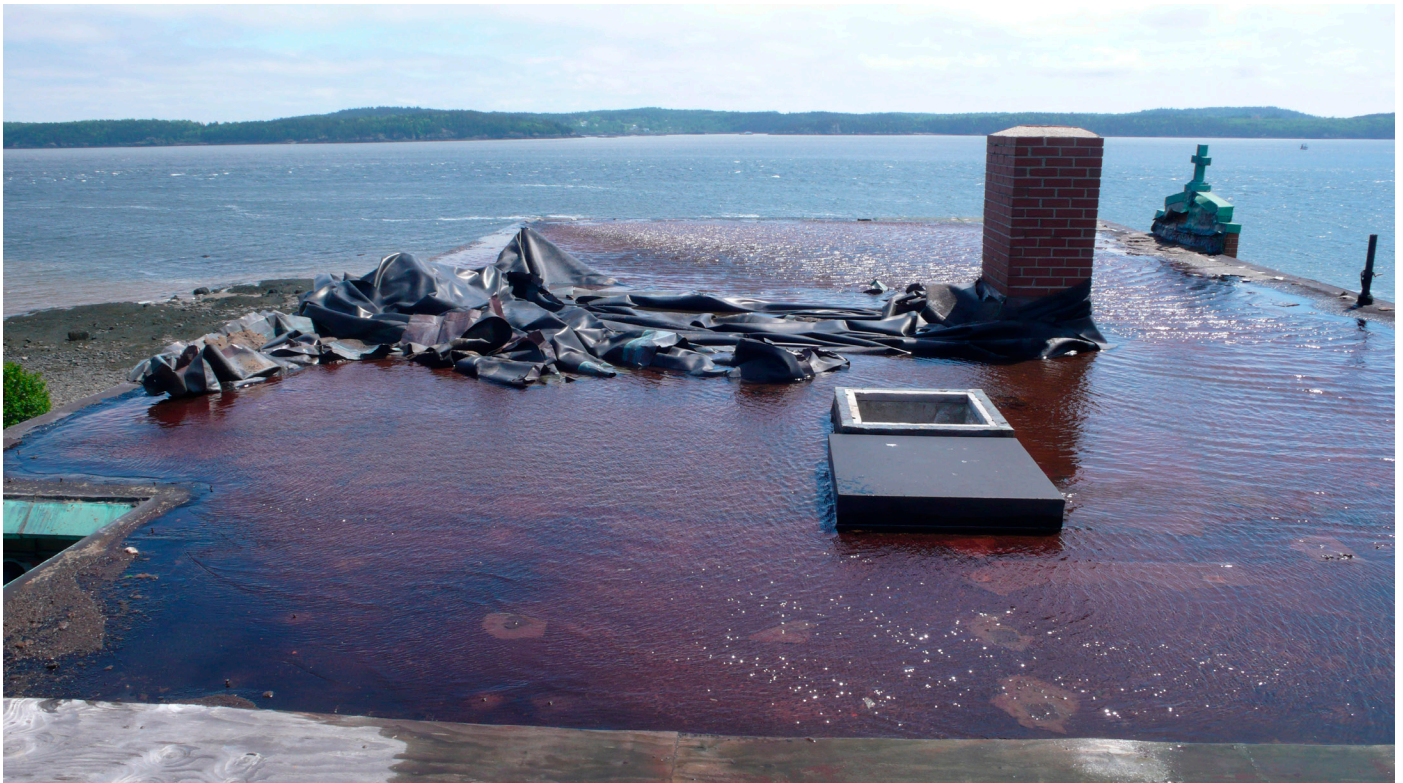
*Another view of the ponding on the Convent roof. The former membrane roof is piled up and useless. All of this water is working its way into the building*

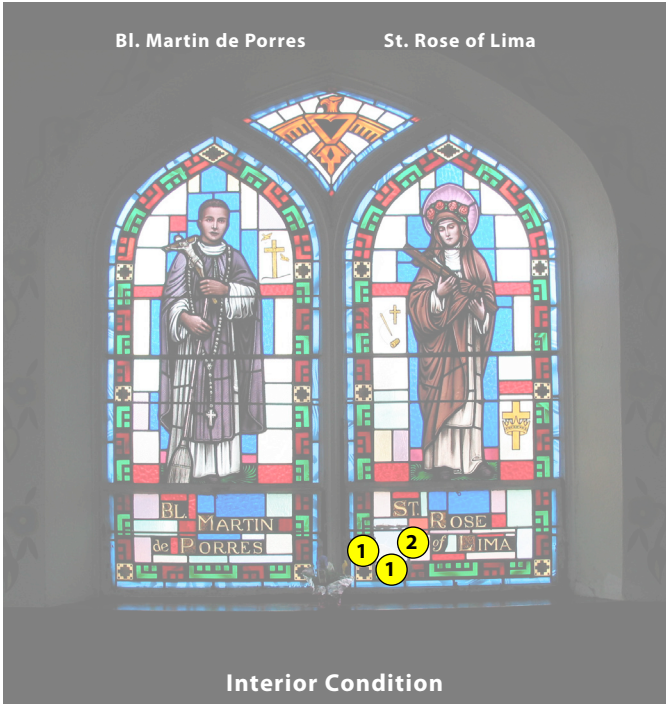
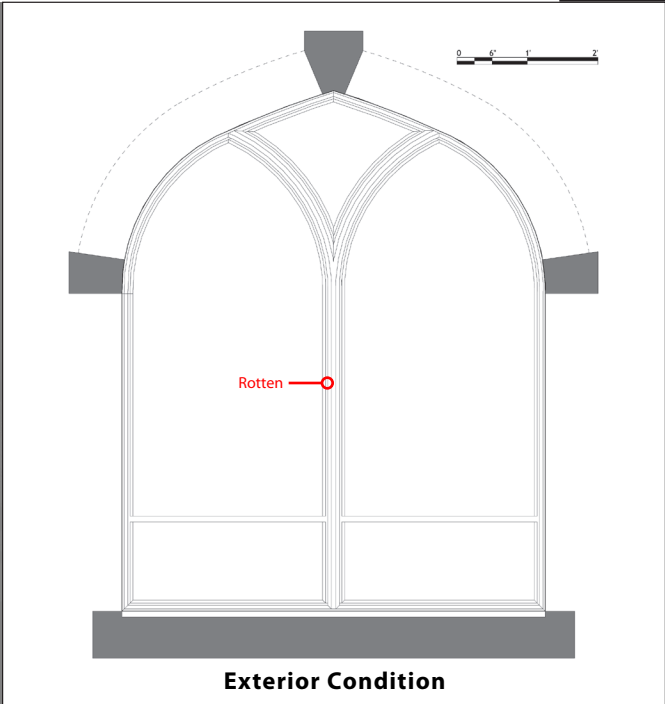
GLASS	left panel	right panel
MAIN Panel	no breaks or fractures	no breaks or fractures
VENT Panel	no breaks or fractures	(2) broken painted pieces; (1) broken piece
